PROVINCE OF NEW BRUNSWICK
ENVIRONMENTAL TRUST FUND (ETF)

FINAL REPORT: Project No.: 140219

Assessing Flood Risk Preparedness in Sussex Corner

Malcolm Mcleod and Paul A. Arp
on behalf of the Village of Sussex Corner

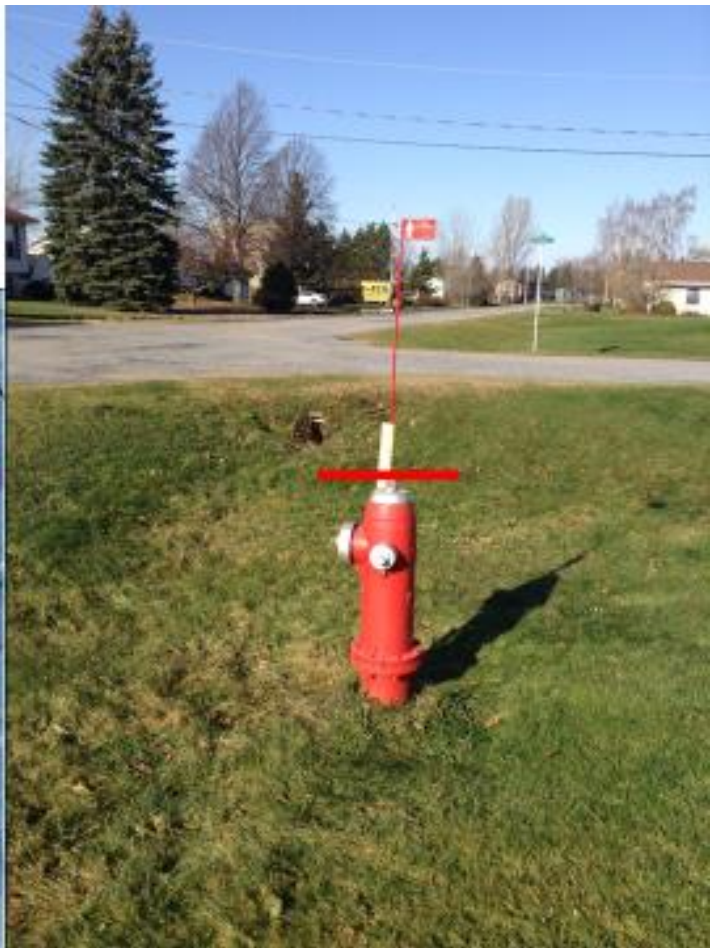
WM1
0.978 m

Parsons Brook flood. Creighton Drive – Stockton Street. Flood filled ditch up to the red mark on top of the water hydrant; Jan. 2014.

The January flood event only affected the areas represented by WM1-WM6. The more severe flooding event in April did not affect this area, but affected the other areas represented by WM7-16. The local January flood may have been caused by local ice/debris jamming along Parsons Brook towards Sussex. The April flood would have been due to rising flood levels everywhere, and especially so along Trout Creek, but the rise along Parsons Brook would not have been as high in April than in January.

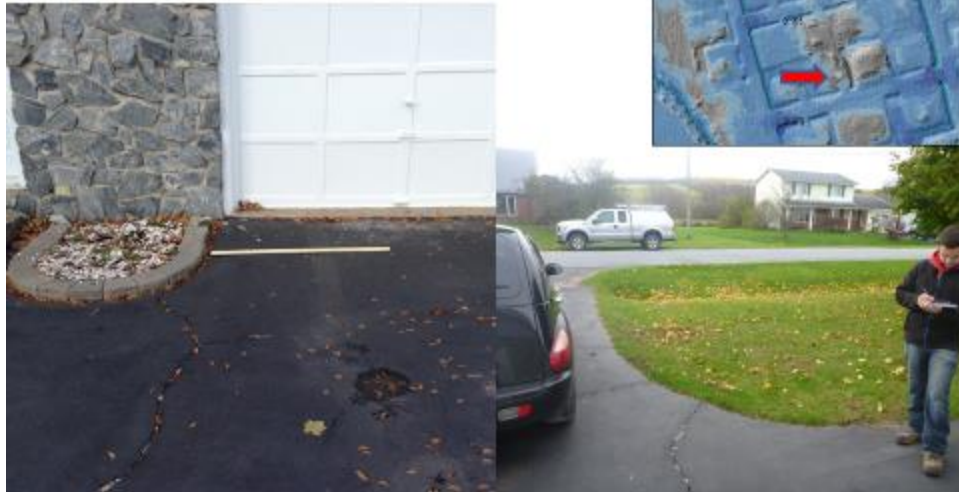
WM2
0 m

Flooding up to garage door, Stockton Street; Jan. 2014.

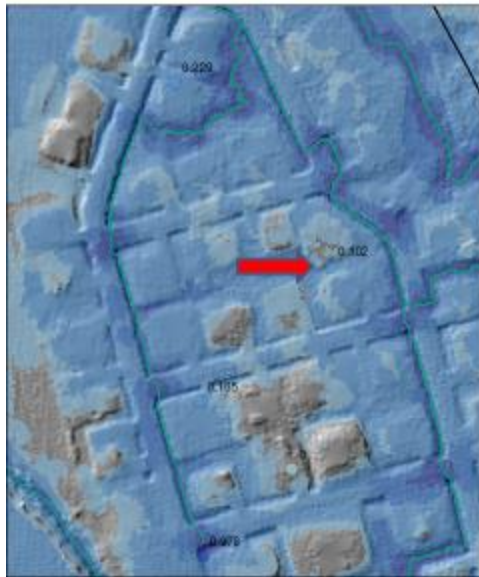
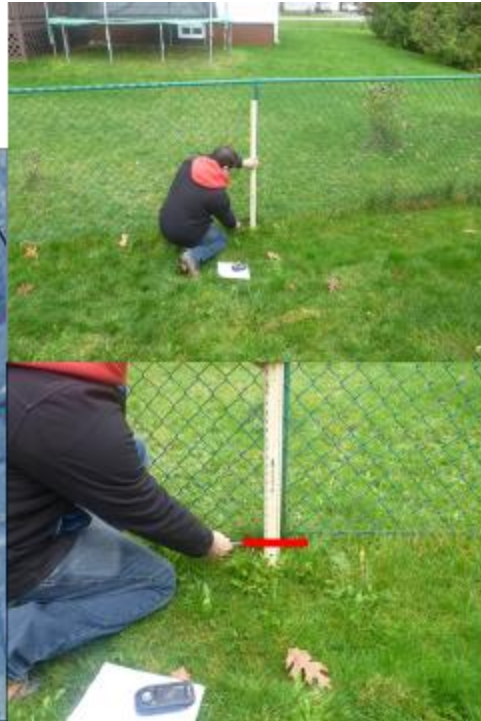
WM4
0.102 m

Flooding to fence line, Skyline Avenue; Jan. 2014.

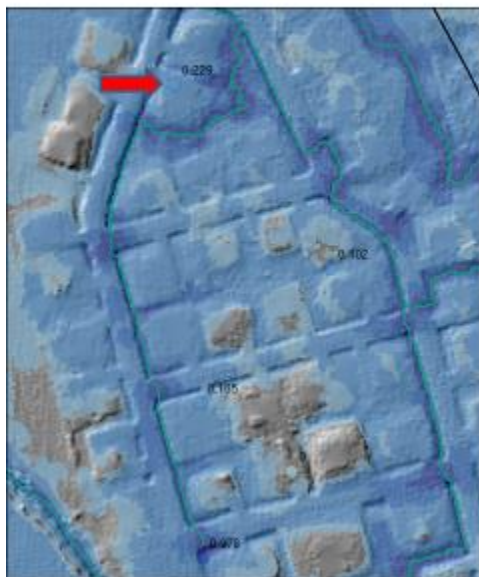
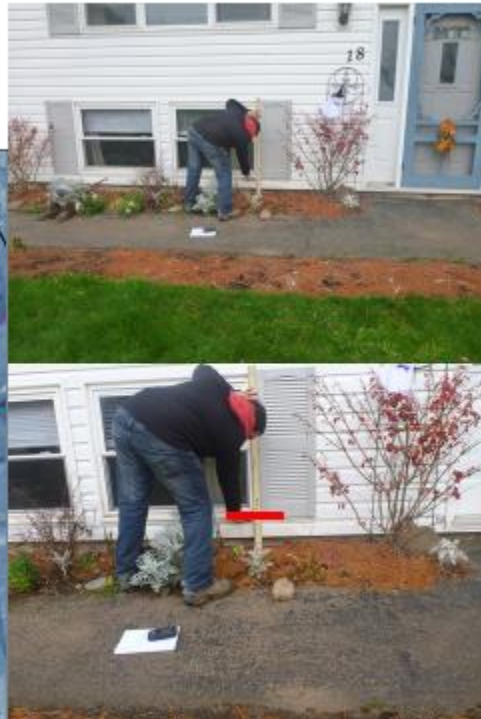
WM5
0.229 m

Flooding at house level, Creighton Drive; Jan. 2014.

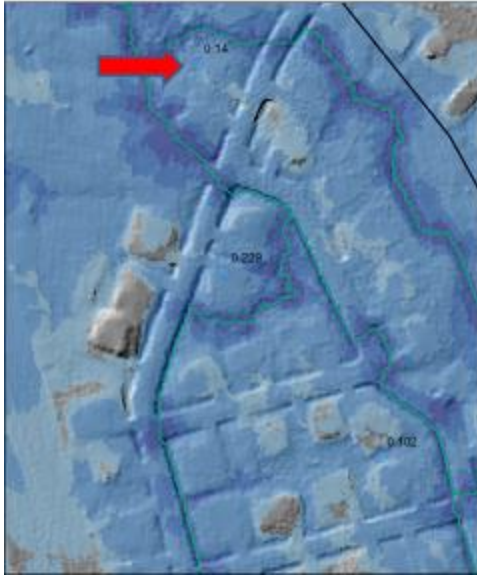
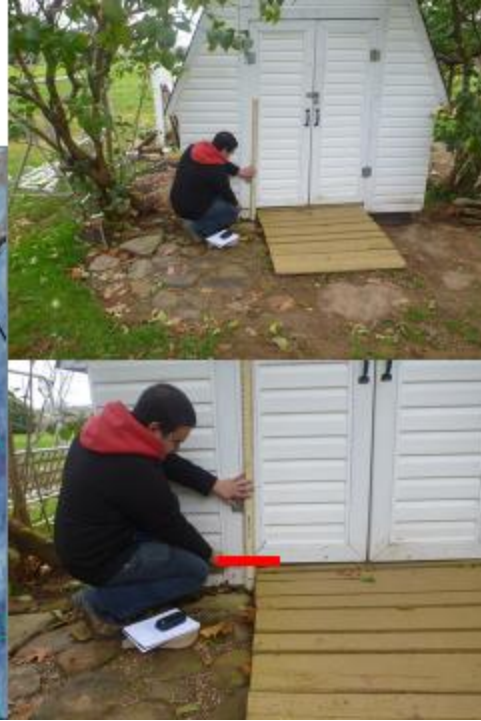
WM6
0.14 m

Flooding at house level, Creighton Drive; Jan. 2014.

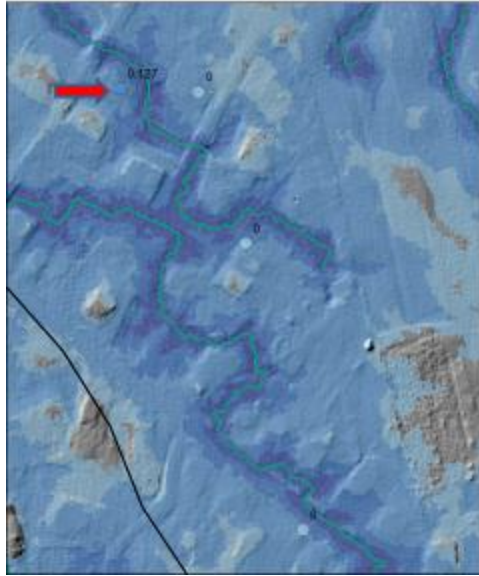
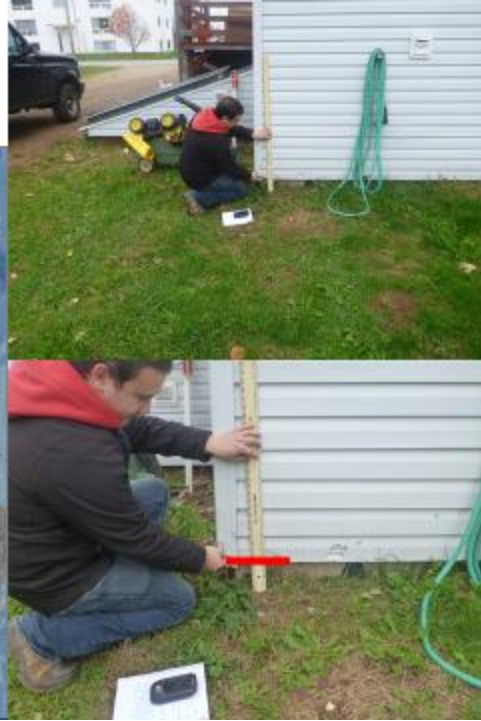
WM7
0.127 m

Water reaching house at Harding Avenue; April 2014.

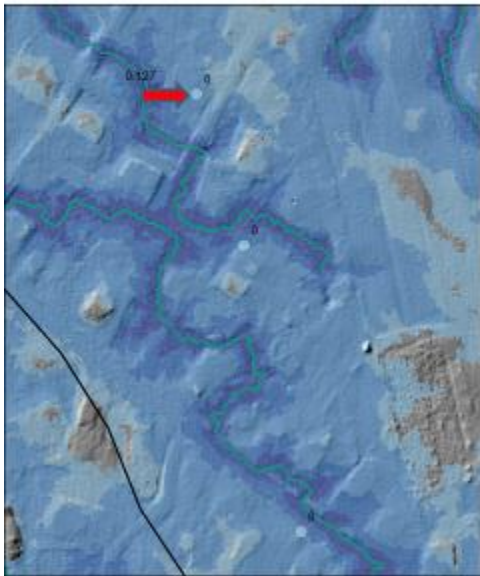
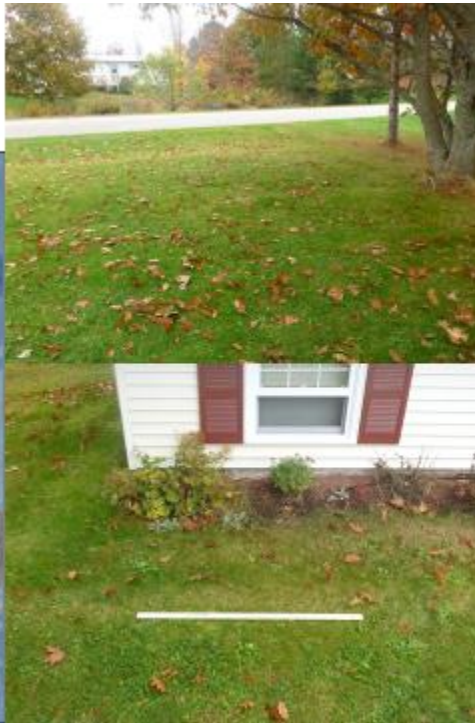
WM8
0 m

Water almost reaching house on Geldart Street; April 2014.

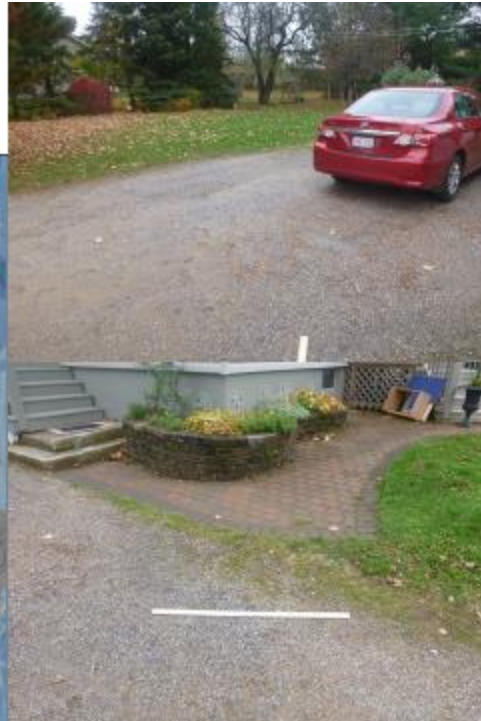
WM9
0 m

Water almost reaching house on Webster Avenue; April 2014.

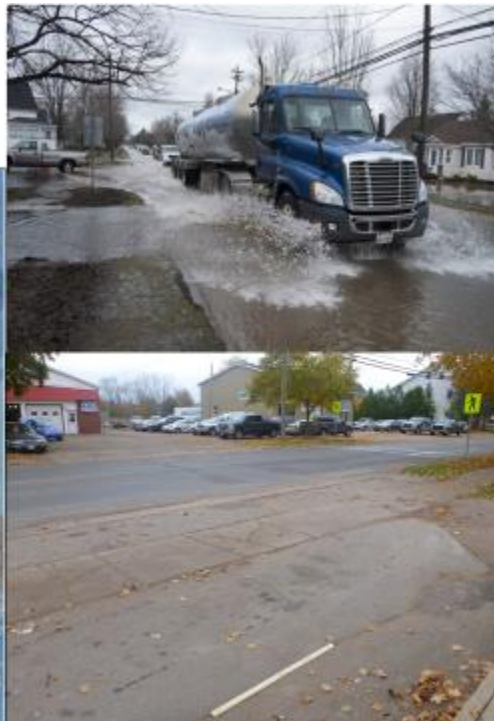
WM10
0 m

Water overflowing Main Street. White mark shows extent of flood; April 2014.

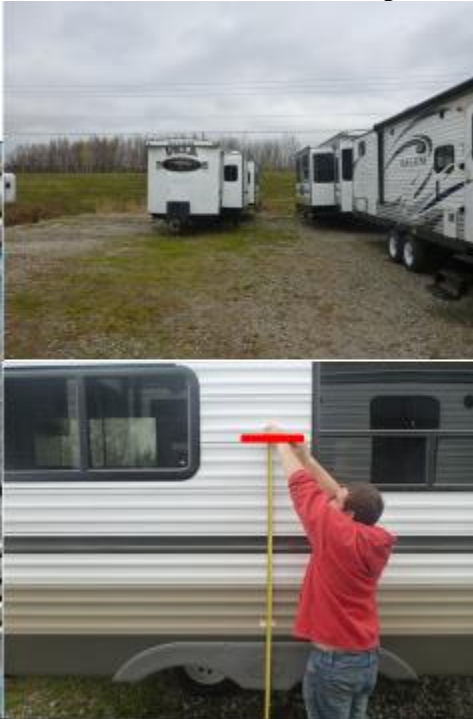
WM11
1.93 m

Water backing up in a depression towards Highway 1 along Leonard Drive. Flooding was aggravated by culvert blocking; April 2014.

Fig. 5. LiDAR-DEM-derived extent of areas likely subject to flooding, on account of three causes: flooding due to rising water levels in the Kennebecasis River and its tributaries, colored dark to light brown, up to 1.75 m, (ii) combined depression on flow channel flooding, colored dark to light blue. The dots refer to in-field verify after-the-fact in-field verifications of the January (WM 1-6) and April (WM7-16) 2014 flooding events, generally conforming to (i) the combined LiDAR-derived depression on flow channel flooding projection, and (ii) the flood crests along bridges (e.g., WM14), and culvert-based flow restrictions (WM11).

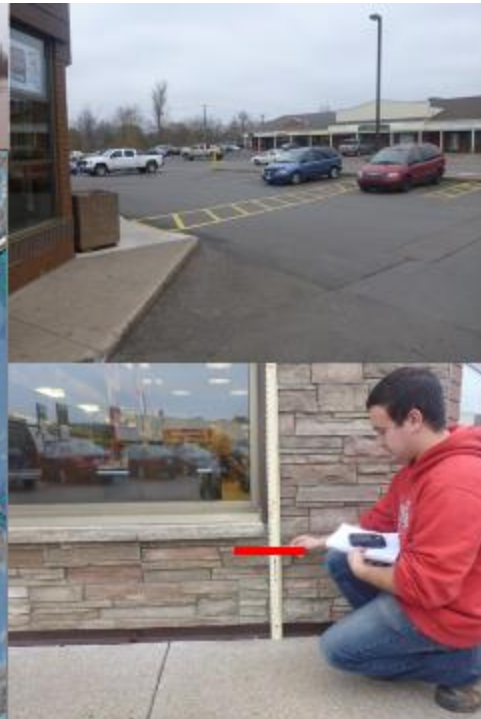
WM13
0.408 m

Water flood level at Tim Hortons, Sussex; April 2014.

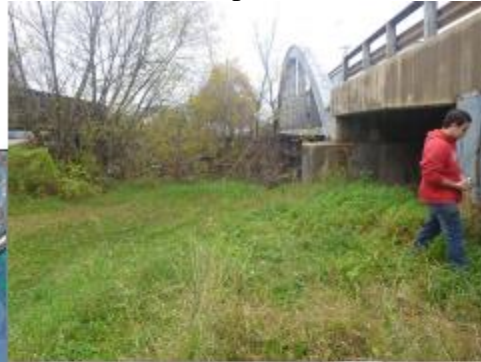
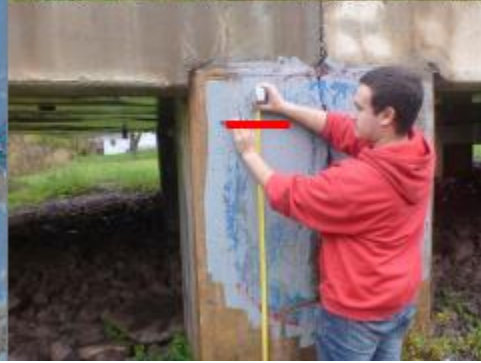
WM14
1.587 m

High water mark at the Trout River Bridge along Main Street; April 2014.

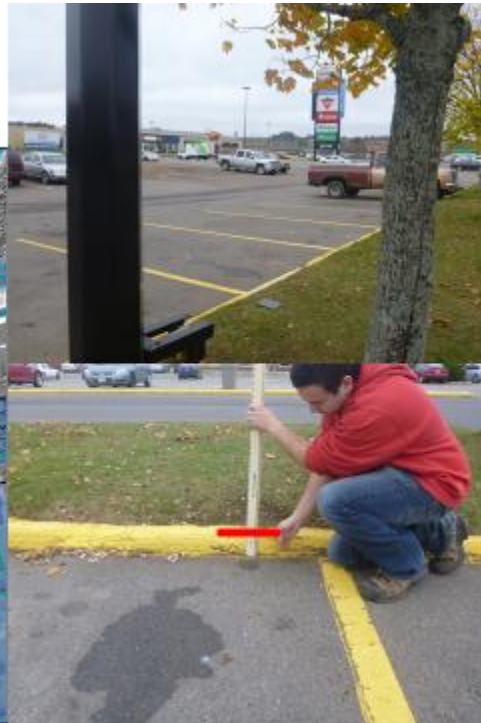
WM15
0.102 m

High water mark at the Canadian Tire parking lot in Sussex, due to low lying area; April 2014.

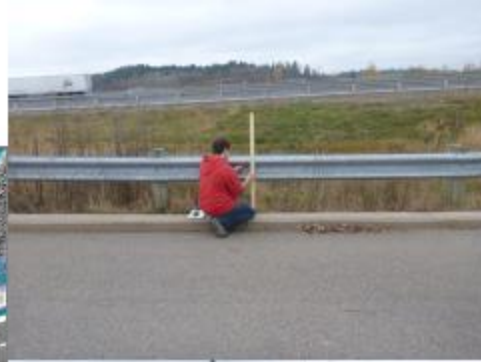
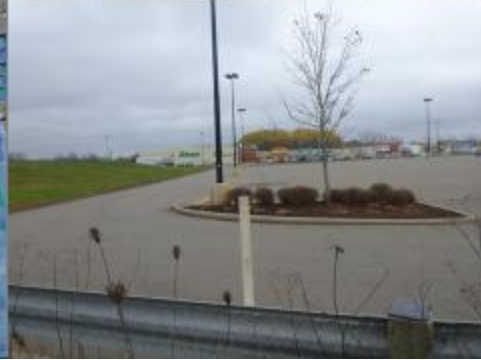
WM16
0.571 m

High water mark at the Walmart parking lot in Sussex, due to river flooding; April 2014.
